Analysis of Anode Layer Thruster Guard Ring Erosion

Colleen Marrese*, James E. Polk†, Lyon B. King*, Charles Garner†, Alec D. Gallimore‡, Sasha Semenko£, Sergei Tverdoklebov§, Valeri Garkusha£

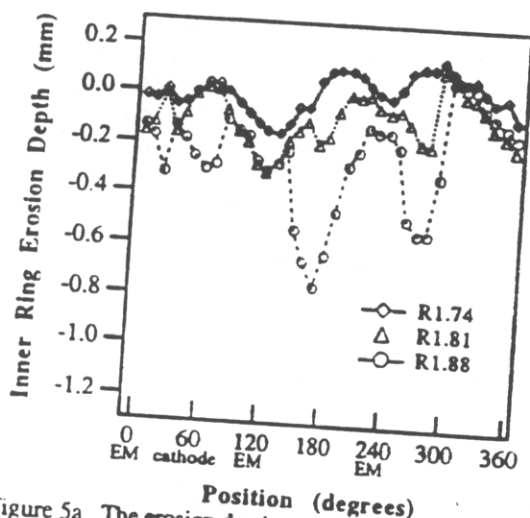
Figures 5a and 5b display a pattern that corresponds to a greater erosion between the electromagnets for the outer edge of the inner guard ring at position R1.74. At the two other radial positions the pattern is almost reversed, with surface heights that are higher than were originally measured. The measurements imply that some of the material eroded off of the outer edge of the inner guard ring was then deposited on the inner edge. The rough texture of the stainless steel surface near the inner edge is characteristic of sputtered material that was redeposited.

Figure 5a. The erosion depth measured on the inner guard ring at the three radial positions noted on the graph. The radial positions are given in centimeters.

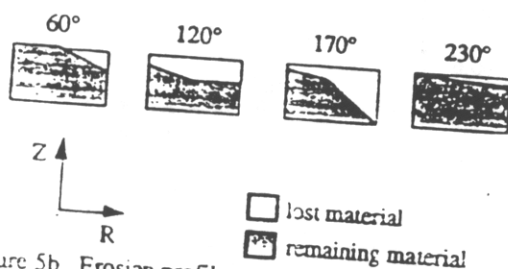
Figure 5b. Erosion profiles on the inner guard ring at the noted azimuthal positions in figure 5a.

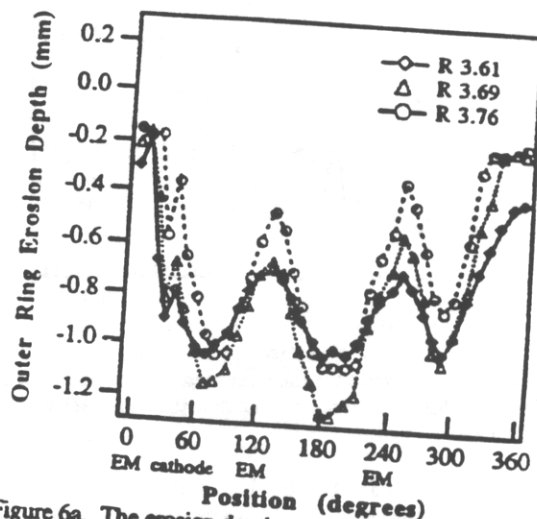
Figures 6a and 6b show that the stainless steel was eroded off of the outer guard ring at a much higher rate than on the inner ring. The sinusoidal pattern has erosion maxima in the positions between the propellant inlets and electromagnets. The inner edge of the outer ring

eroded to a maximum depth of 1.26 mm because the guard ring is flush with the surface of the anode at this depth. This shadowing effect by the anode prevented further erosion of that edge of the ring; however, the middle of the ring continues to be eroded beyond the limiting depth set by the anode surface. The only positions where the erosion depth in the middle of the ring exceeds the inner edge erosion depth are those where the inner edge was eroded to the height of the anode, at 70°, 190°, and 290°.

Figure 6a. The erosion depth measured on the outer guard ring at the three radial positions noted on the graph. The radial positions are given in centimeters.

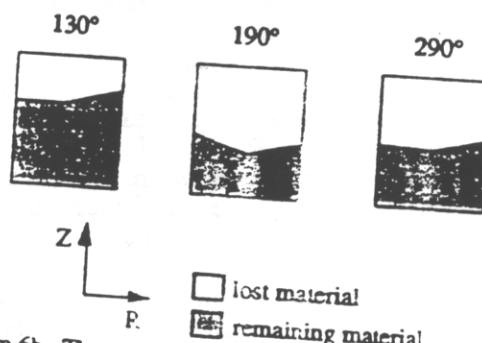
Figure 6b. The erosion profiles at the noted azimuthal positions in fig. 6a.

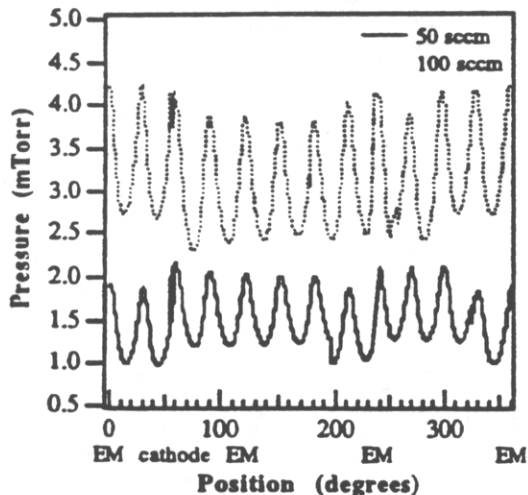
The measurements taken to evaluate the uniformity of the propellant are presented in fig. 7. The twelve peaks correspond to the positions of the propellant inlets. The data show no correlation between the pattern etched in the

guard rings and the mean value of the pressure. There seems to be no pattern in the pressure distribution. Although there are fluctuations in the pressure, the fluctuations measured at both flow rates are different. From the data obtained, it seems that the erosion patterns were not caused by propellant fluctuations.

Figure 7. The pressure measurements taken inside of the anode at 6.25 mm from the 12 distribution holes at 100 sccm and 50 sccm.

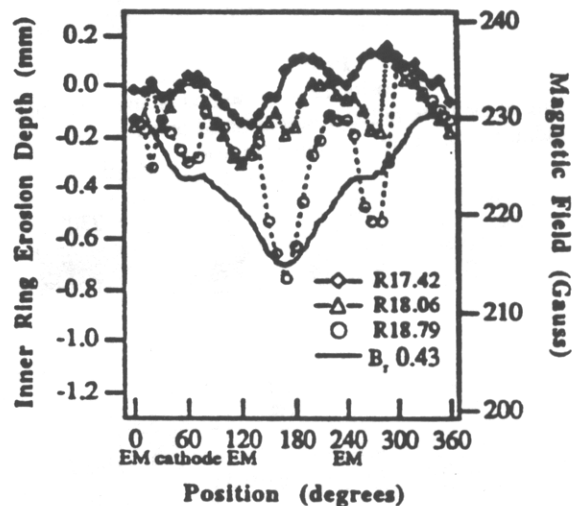
Figure 8 shows the magnetic field at position B.43 because at positions closer to the inner guard ring there is a 6% single dip in the field at 168°. This large fluctuation in the magnetic field strength is generated by the gap between the inner electromagnet and the anode. The actual field fluctuations at the ring surface might be different.

The pattern etched in the inner guard ring does not follow any of the magnetic field patterns that were measured as well as the outer ring followed E.94 (fig 8). However, the general tendency to higher erosion rates between the outer electromagnet positions for the outer edge of the ring is consistent. It is believed that the pattern etched in the ring follows the magnetic field topology in the region closer to the inner ring and anode. Because of the size of the probes that were used, the closest position that could be evaluated was G.94, however, it is possible that the majority of the ions were not coming from this region, but further upstream.

Figure 8. A comparison of the inner guard ring erosion to the azimuthal magnetic field variations at the position B.43 that is illustrated in figure 5.

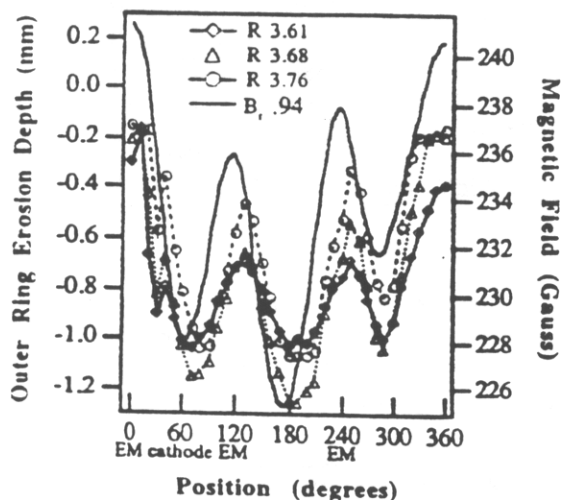
Figure 9 shows how the erosion pattern etched on the outer guard ring matches the magnetic field non-uniformity. Since the erosion pattern follows the configuration of the magnetic field in

position E 94 ions might have originated near the position. In the weak magnetic field regions the guard rings were eroded to a pattern that implies that radially directed ions sputtered the material off of the ring until the anode shadowed the inner edge of the ring. As the erosion pattern and electric field near the ring evolved, it is possible that the ions were accelerated from positions further downstream of the anode.

Figure 9. A comparison of the outer guard ring erosion to the azimuthal magnetic field variations at E .94.

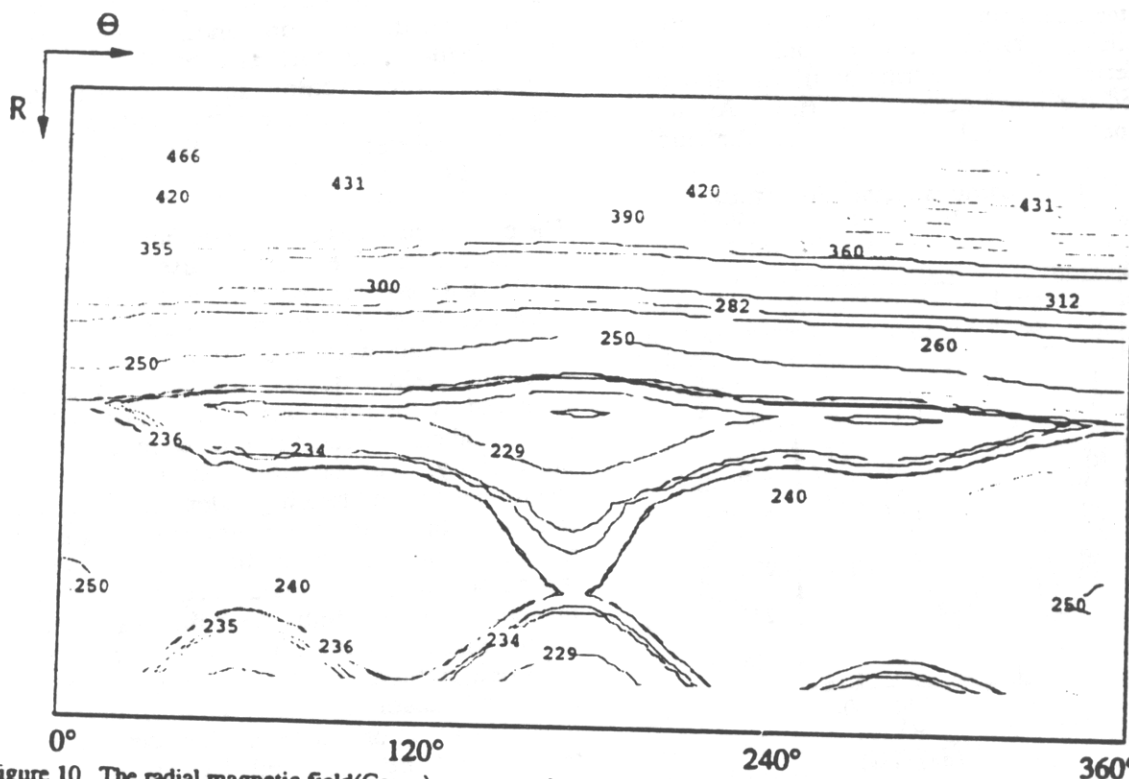
Figure 10. The radial magnetic field(Gauss) contours taken in the .94 plane shown in fig. 4.
