Analysis of Anode Layer Thruster Guard Ring Erosion

Colleen Marrese*, James E. Polk†, Lyon B. King*, Charles Garner†, Alec D. Gallimore‡, Sasha Semenko£, Sergei Tverdoklebov§, Valeri Garkusha£

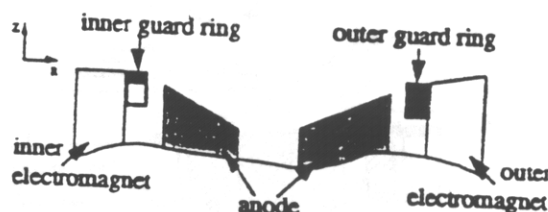
Figure 2. A diagram showing the position of the guard rings. The dark area of the rings are presented in figures 6 and 7, showing the erosion profile after 636 hours.
